Reinforced Scraper Mounting Shaft.

Buhler
Customer Service
Grinding &
Dispersion.

For Three-Roll Mills SDV- and SDVE- 1100 and 1300.

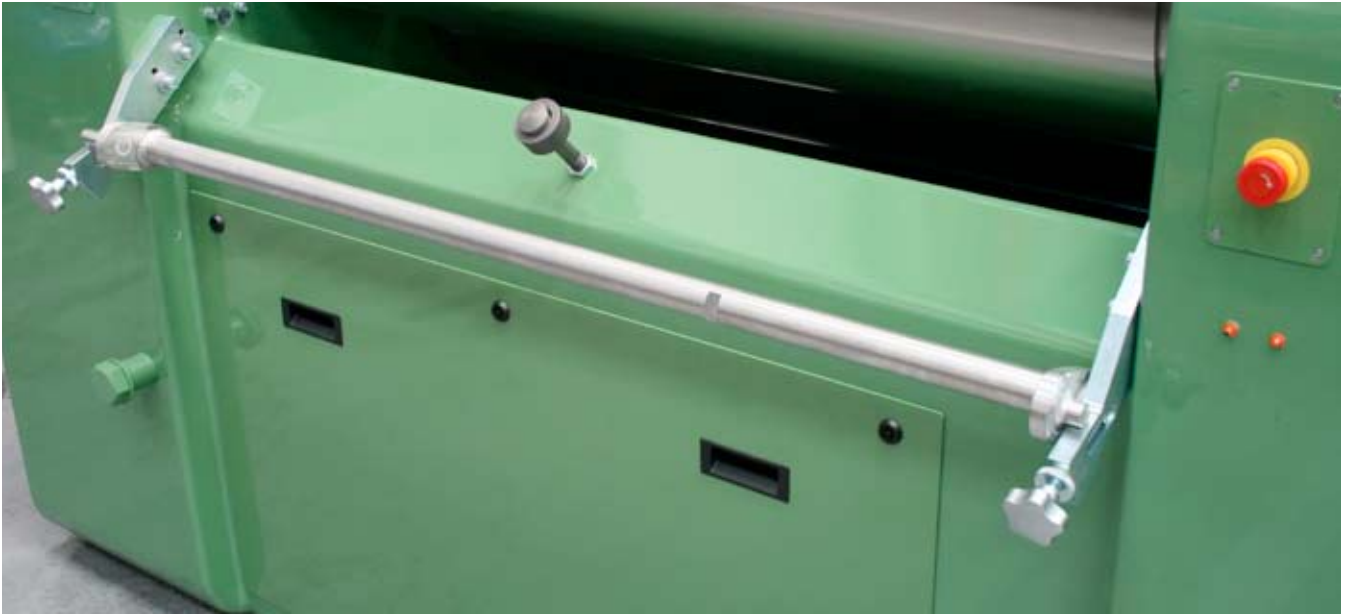
On a rare occasion, the welded stop on existing mounting shafts might fail. This is because the run-off plate carrying product is pulled too quickly against the stop. The

welded stop could be weakened by the heavy load or, worst case, even torn off.

As part of our maintenance plan, we are able to offer you the reinforced mounting shaft including the two supports.

- Resistant to corrosion
- More fail-safe system
- Higher load capacity
- Increased safety

- Delivery of a complete mounting shaft assembly
- Delivery of both supports including centering pins and screws
